Getting on Track

with Railcar Linings
for Chemical
Service

By Lori R. Huffman, JPCL

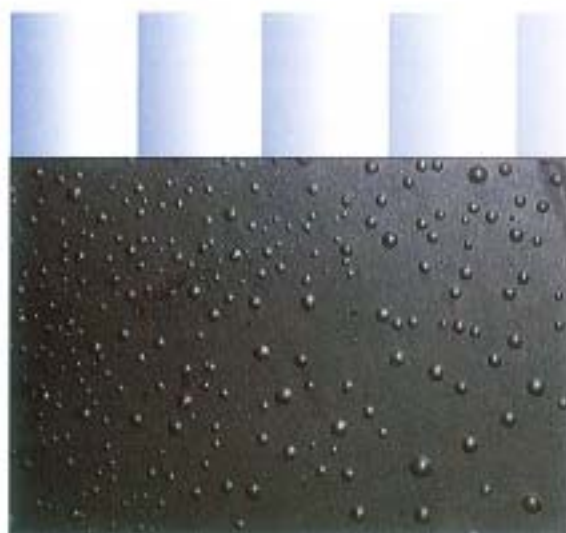
Blistering, such as that shown in the rubber lining at left, has a variety of causes, including proprietary additives in the lining and steam cleaning.
Courtesy of Jim Molnar, Union Tank Car

When the tank cars are cleaned, the linings must withstand more abuse. Typically, water jetting and mechanical or hand scraping are performed, followed by neutralization using a pH extreme that may be the opposite of what the lining is designed to resist, says Molnar. In addition, steam, often used in cleaning operations, can cause linings to blister.

Another problem with lining service exposures is the potential for ladings to contain small amounts of proprietary additives that can adversely affect the linings, says Molnar. The effects of these "mystery" additives can range from blistering, peeling, and flaking to the appearance of a "bathtub ring" in the tank car, he says.

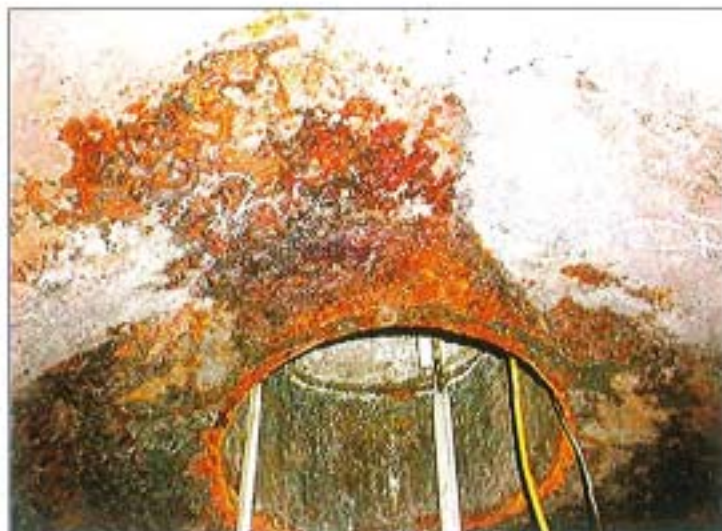
Federal regulations require periodic inspection of lined cars that carry corrosive materials. Molten sulfur service is among the most corrosive environments for railcars. Coating failure at the manway is shown here.

Clayton says that special attention must be paid to inspecting lined areas around attachments to the tank shell, including the manway nozzle, the bolster areas, and the bottom of the car near the outlets.

When molten sulfur is unloaded, these areas cool faster than the rest of the tank car, and residual sulfur can harden and be retained on the steel, laying the foundation for corrosion.

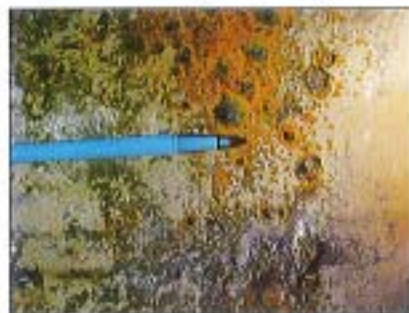
Gathering data on lining performance, like the failure and pitting above, is crucial to improving long-term protection.

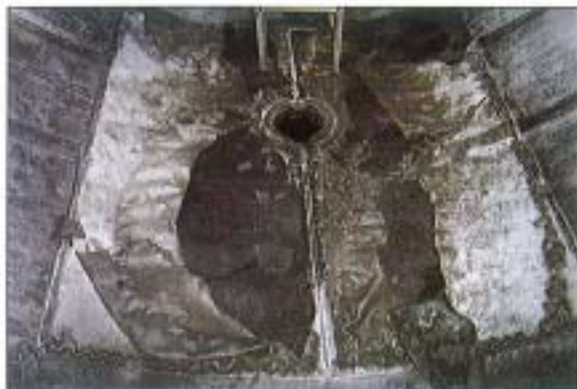
Tank cars must be specially designed for rubber linings to prevent premature failure. Pictured above is a failed and delaminating rubber pad. Courtesy of Jim Molnar, Union Tank Car

formance before requiring work. The catch, however, is that the tank cars have to be designed specifically for rubber linings, not least because these materials add weight (more than a ton) to the railcar. In addition, the nozzles and fittings on the car must be designed to accommodate the lining or must be eliminated, and all interior edges must be rounded to a $\frac{1}{8}$ -inch (1 mm) radius. Because of these requirements, the choice to use rubber linings has to be planned. "It's best to order new cars, which can take one and one-half to two years [to manufacture]," he says.

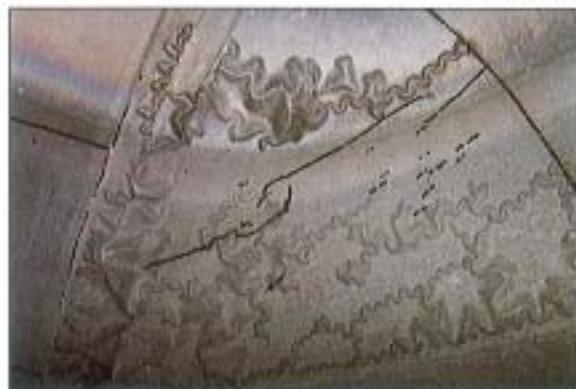
Wrinkled rubber lining on tank car head
Courtesy of Jim Molnar, Union Tank Car

Rubber linings typically consist of thin plies of rubber that are laminated together on a calender. Some of the linings fail due to delamination between plies, says DeLashmit. Extruded rubber linings have a much better surface appearance and may offer longer service life because there are no plies to separate, he says.
